# Manhole Inspection Summary

Manhole # S35A\_\_003MH

**Location** Address: **601 hunter st**

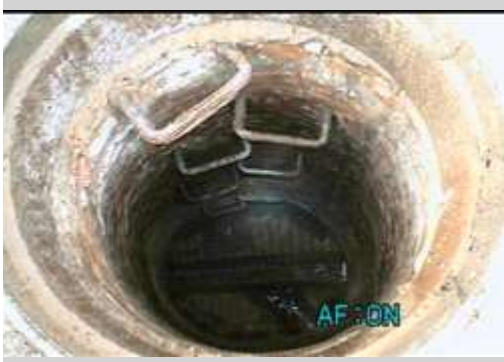
Defect 2

Count: **7** Missing: **0** ☒ **Corroded**

corr steps

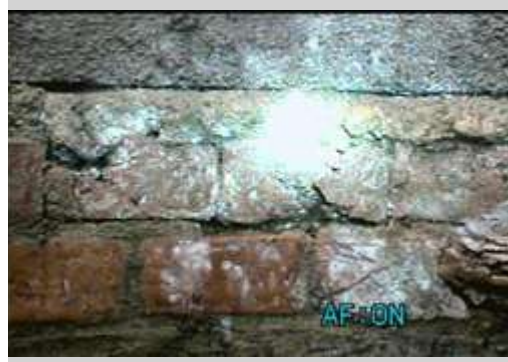
Defect 1

Condition: ☐ Sound ☐ Cracked ☐ Root Intrusion ☐ Loose Brick ☒ **Deteriorated**

chimney deteriorated, frame adj

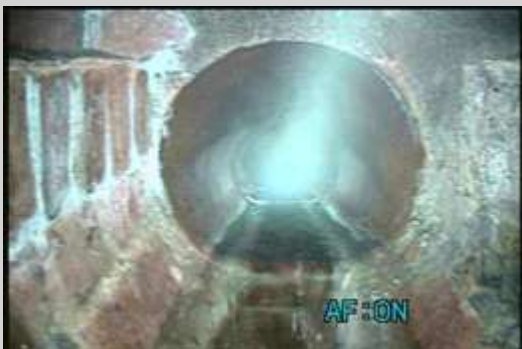
6 O'Clock Inflow

steamy
